Durability Project Mineral wool

Report on findings E3.3-2016/01

Subject: Durability Project Mineral wool

Report No.: E3.3-2016/01

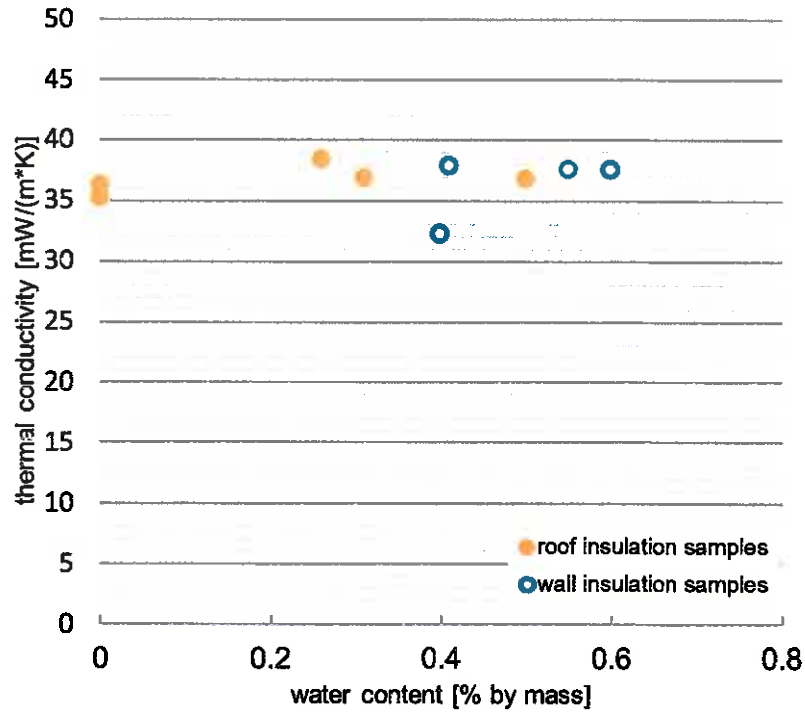
Figure 2: thermal conductivity vs. water content by mass of the thermal conductivity samples at the time of testing.

Figure 2 shows all measured thermal conductivity values for both applications as a function of the samples' water content. The differences in measured moisture content did not show significant impact on thermal conductivity. This demonstrates that both the water content in the constructions was inconsequential for the thermal properties and the sensitivity of the thermal performance of mineral wool to moisture in the expectable range for faultless constructions is very low.

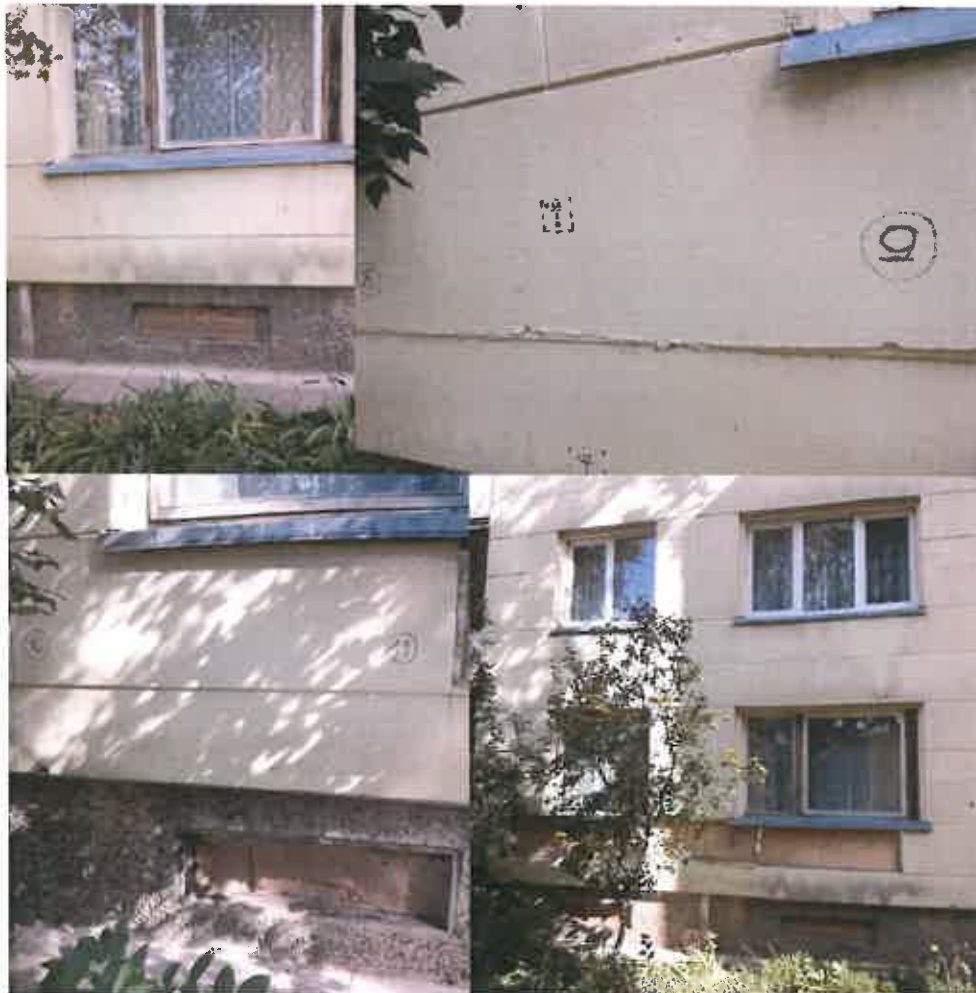
Samples were taken from the south-west orientation façade of building: No6; No7; No8; No9; No10; No11 (Figure 5). The specimen No8 was prepared for determination of moisture content.

Figure 5. Samples were taken from the south-west orientation façade of building: No6; No7; No8;
No9; No10; No11.
